Outfall Inspection Summary

Outfall Name: Drain B

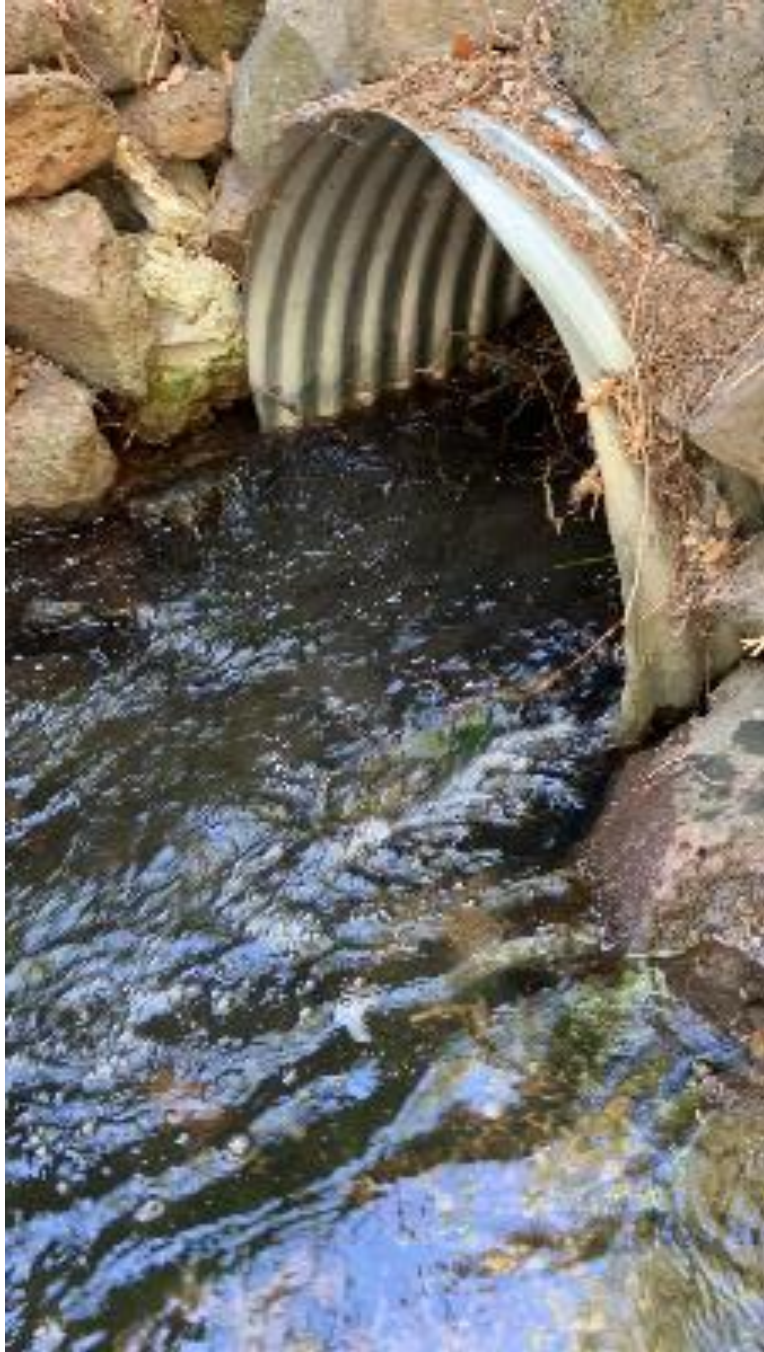
Receiving Waters: Logger Creek	Pipe Type: CMP Pipe Size: 36"	Lat: 43.58975 Long: -116.18095				
Date: 6/24/2024 Personnel: KC, EL	Comments: Outfall screened on the east side of E Parkway Dr. The presence of detergents exceeds benchmark values.					
Structural Condition	Good					
Sedimentation	None					
Staining	None					
Odor	None					
Vegetation	Typical					
Floatables (Not Trash)	None					
Trash Observed	None	<table border="1" style="width: 100%; border-collapse: collapse;"> <tr> <td style="width: 25%;">Trash Rank</td> <td style="width: 25%; text-align: center;">--</td> <td style="width: 25%;">Trash Source</td> <td style="width: 25%; text-align: center;">--</td> </tr> </table>	Trash Rank	--	Trash Source	--
Trash Rank	--	Trash Source	--			
Flow	Yes	<table border="1" style="width: 100%; border-collapse: collapse;"> <tr> <td style="width: 25%;">Amount</td> <td style="width: 25%; text-align: center;">Substantial</td> <td style="width: 25%;">Flow Rate(cfs)</td> <td style="width: 25%; text-align: center;">0.7743</td> </tr> </table>	Amount	Substantial	Flow Rate(cfs)	0.7743

Illicit Discharge?	Unlikely
---------------------------	----------
